TASK FORCE REPORT

PORTLAND CEMENT CONCRETE PAVEMENT PERFORMANCE INTERSTATE 84

PENNSYLVANIA STATE LINE TO CONNECTICUT STATE LINE

MARCH 1978

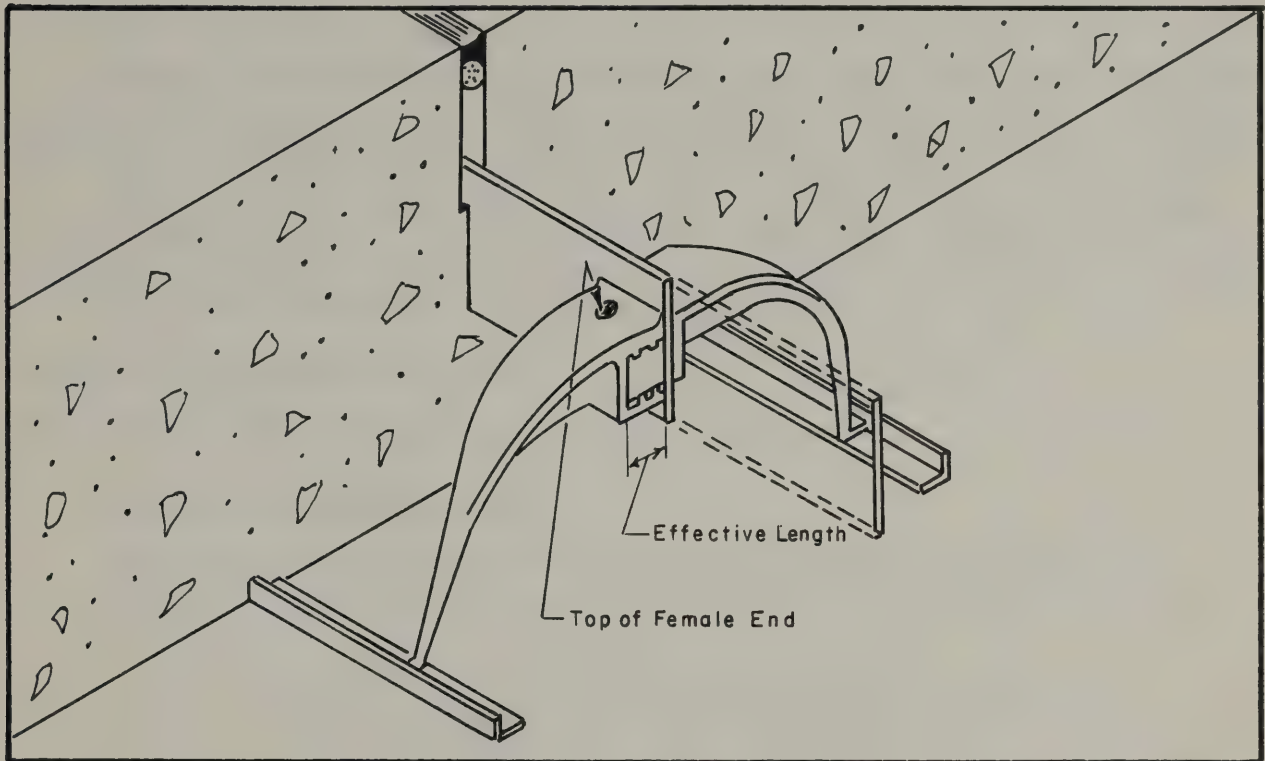
FIGURE 2. LOAD TRANSFER DEVICE

The three samples from the areas classified as "good" showed the joint assemblies, except for minor corrosion, are much the same as originally installed. The top of the female end is still intact in each case. See Figure 2. The

joints represented by these samples are still functioning as load transfer devices and may continue to do so indefinitely barring any significant change in conditions. See photographs in Appendix.

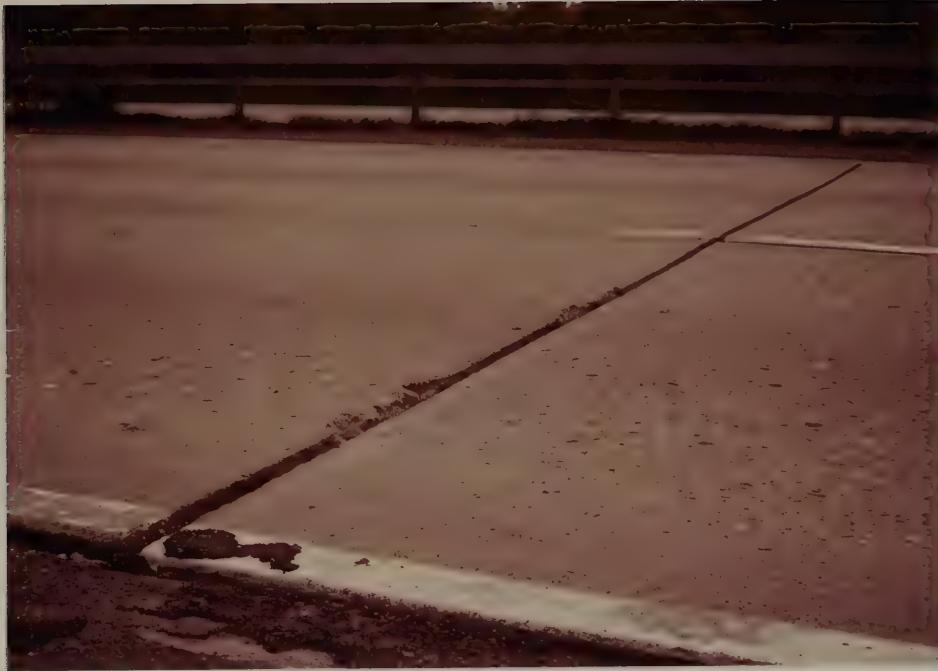
PHOTO 1

A general field inspection of the entire length of roadway, both eastbound and westbound, was made with stops at typical problem areas to identify the distress type, severity and approximate frequency of occurrence. The predominate pavement distress was observed to be faulting of transverse joints in the travel lane. See Photograph 1.

TYPICAL FAULTING PROBLEM ON INTERSTATE 84.
PHOTO TAKEN ON CONTRACT FISH 62-1

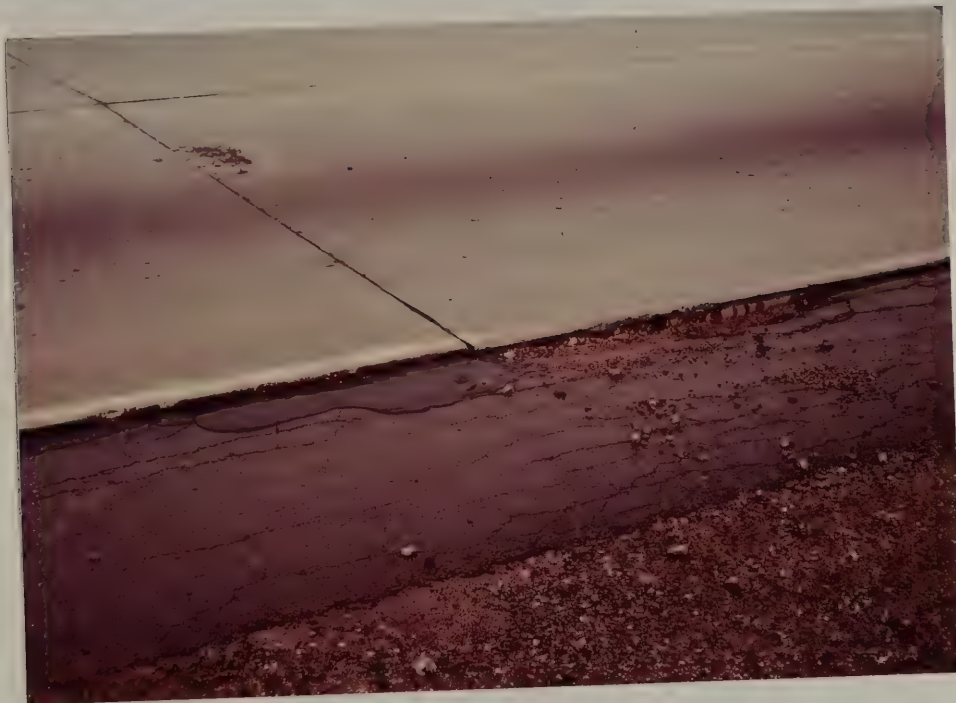
PHOTO 2

"BLOWHOLE" DEVELOPED AT PAVEMENT-SHOULDER
INTERFACE APPROXIMATELY TWO FEET BEYOND
JOINT IN DIRECTION OF TRAVEL

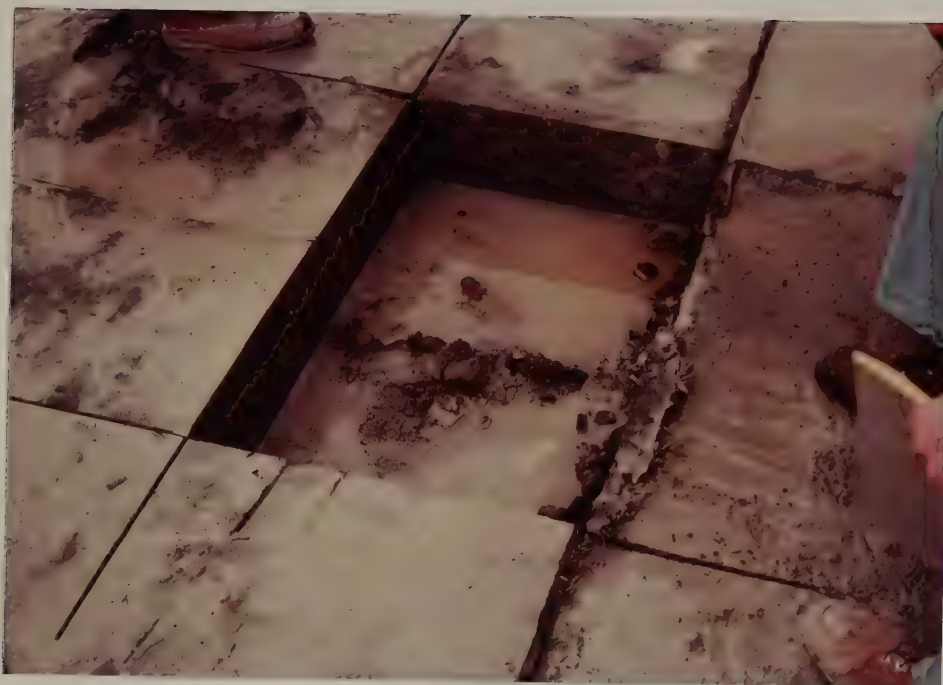
PHOTO 3

The results of gradation testing on the material from the ridge found directly under the joint showed it to have a top size of two inches and up to twenty percent passing the No. 200 mesh sieve. Included in the ridge material were pieces of concrete which had spalled from beneath the joint assembly. The height of the ridge ranged from 0.6 inches to 1.8 inches. See Photograph 3.

RIDGE OF MATERIAL FOUND BENEATH JOINT
AFTER REMOVAL OF PAVEMENT SECTION.
WATER PRESENT IN PHOTO FROM SAWING OF
PAVEMENT.

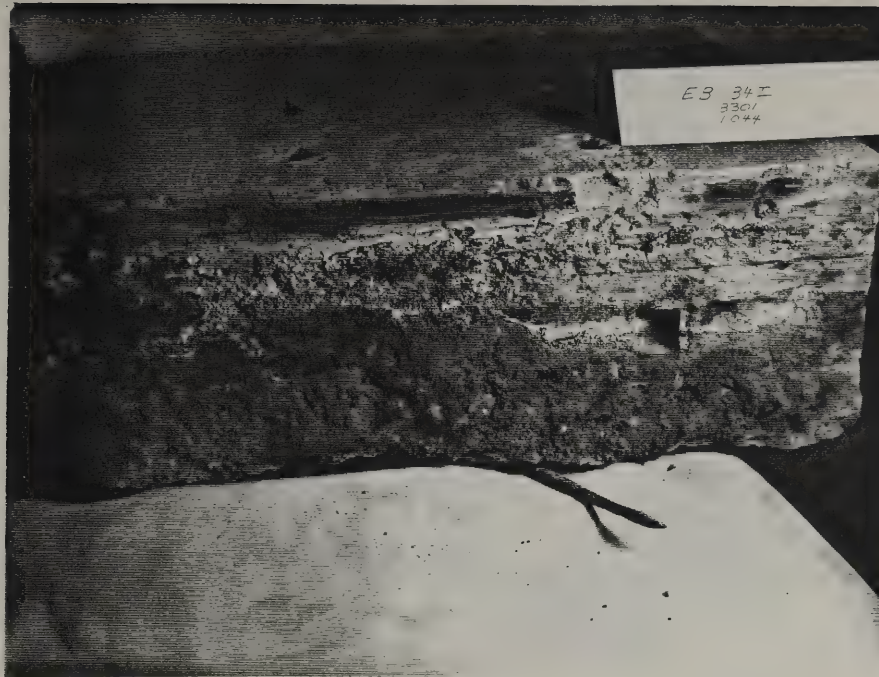
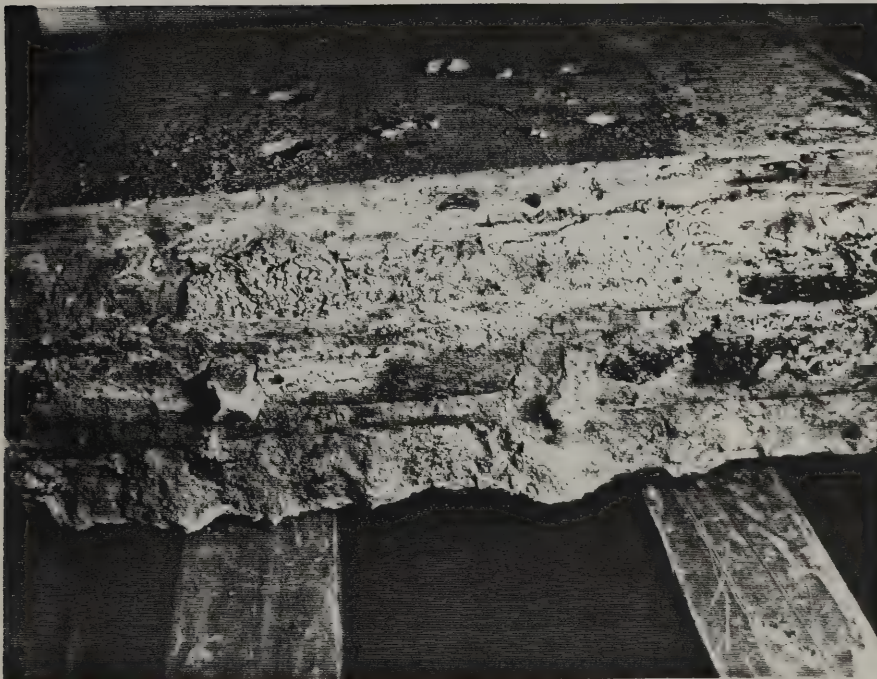
FISH 64-9 84I-83011044 E.B.

GOOD JOINT

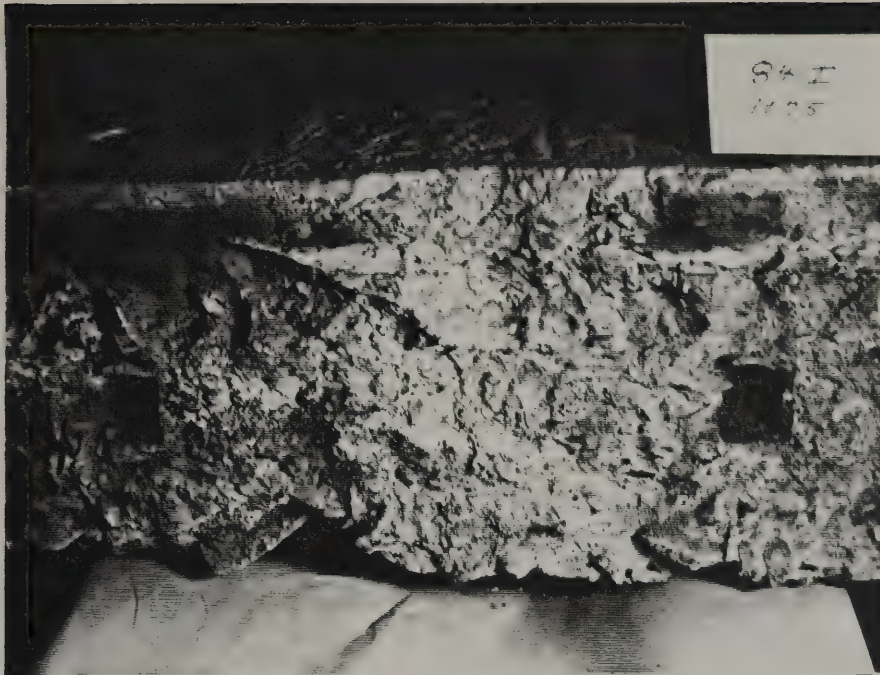
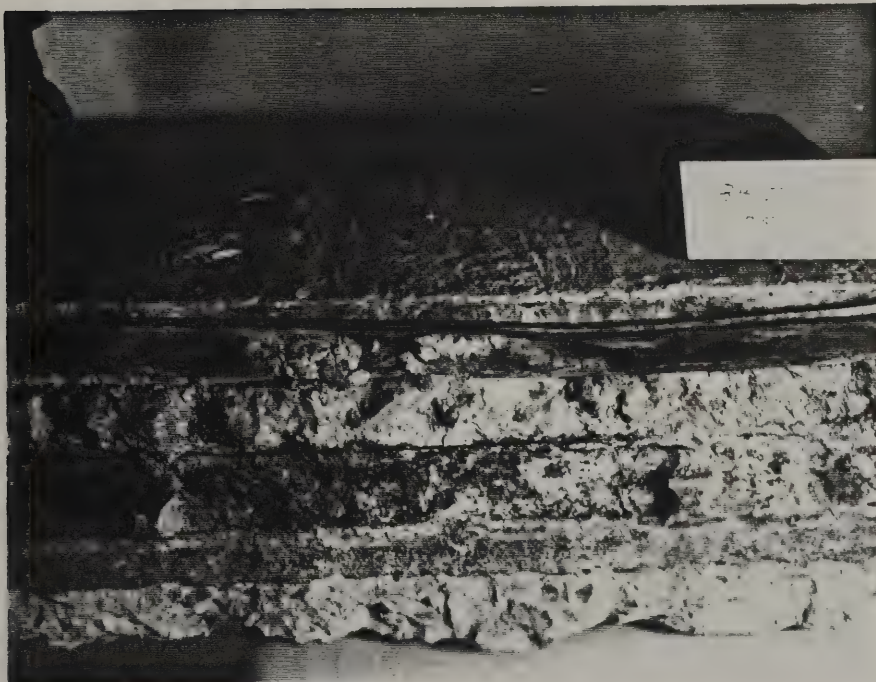
FISH 66-8 84I-8301175 W.B.

GOOD JOINT.

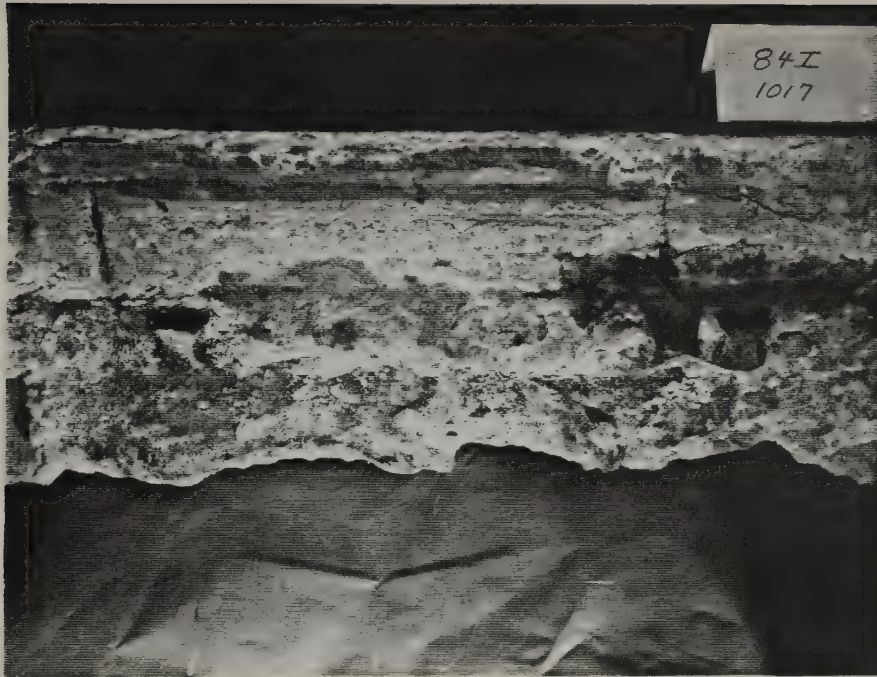
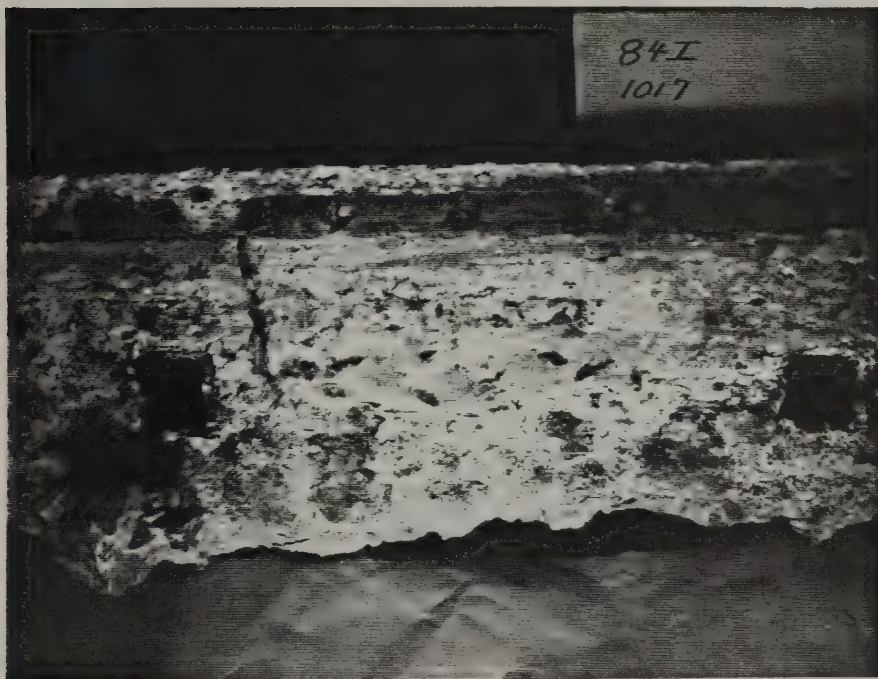
FISH 62-1 84I-82021017 W.B.

GOOD JOINT

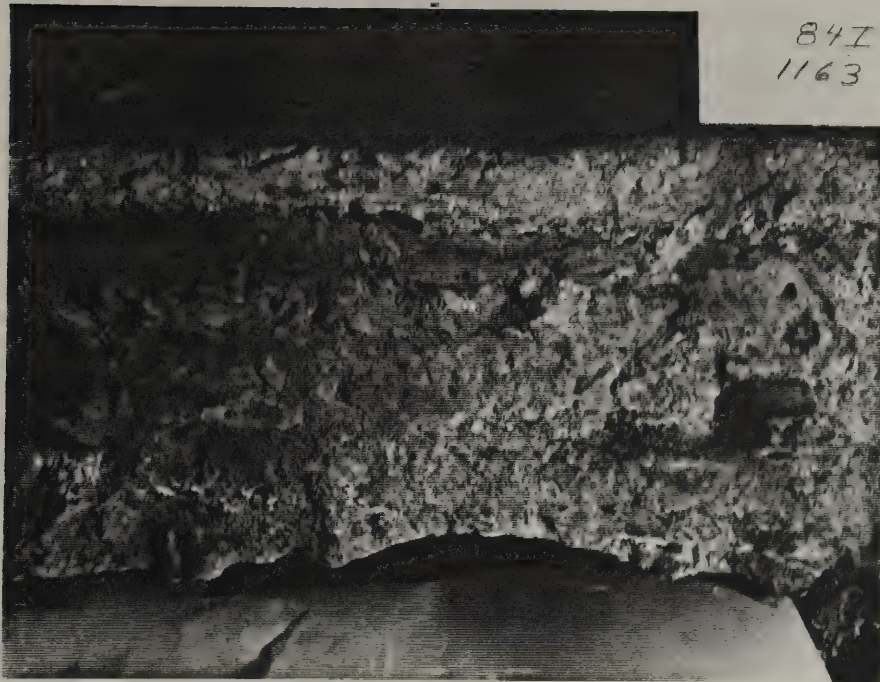
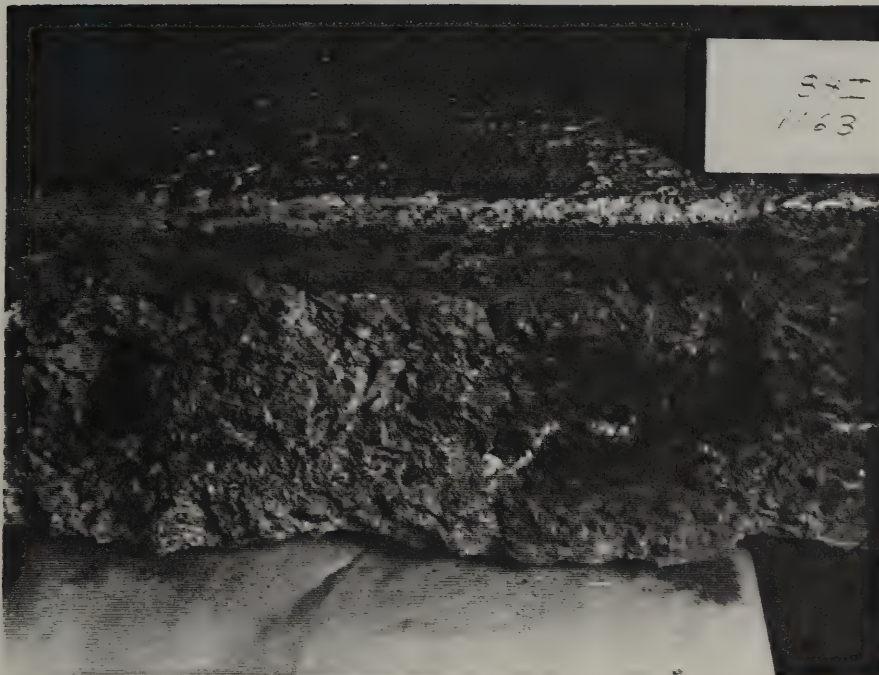
FISH 66-8 84I-83011163 E.B.

The centerplate and other exposed parts of the joint assembly showed corrosion to some degree. The three samples from the areas which were classified as "poor" showed the top plate of the female end had been worn away due to a combination of corrosion and abrasion which allowed the male end to move in a vertical direction beyond the original dimension of the assembly. It was observed that the movement of the male part resulted in a wearing away of the concrete immediately above the original female insert which created a vertical slot in which the male end can move. It is most likely that the existing condition resulted from a cycle of faulting leading to elongation of the

POOR JOINT

NOTE: Top portion of female section is missing, also elongation of hole.

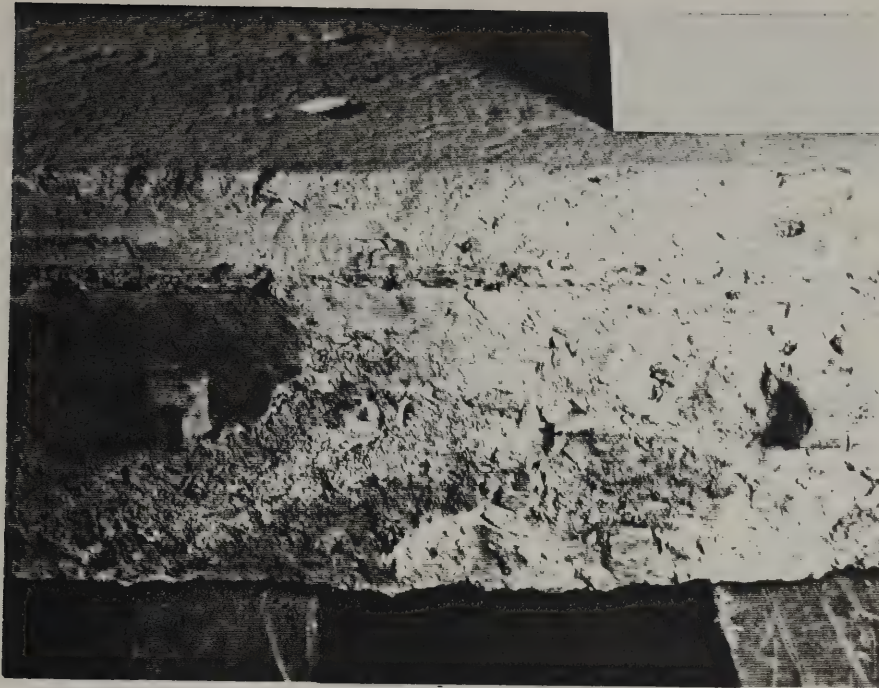
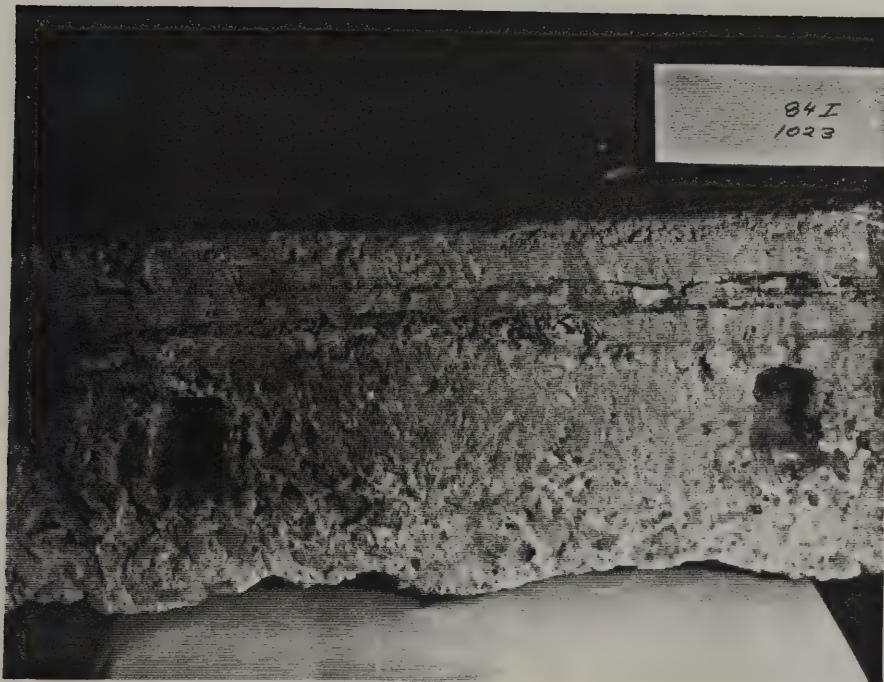
FISH 62-1 84I-82021023 E.B.

POOR JOINT

NOTE: Top portion of female section is missing, also elongation of hole.

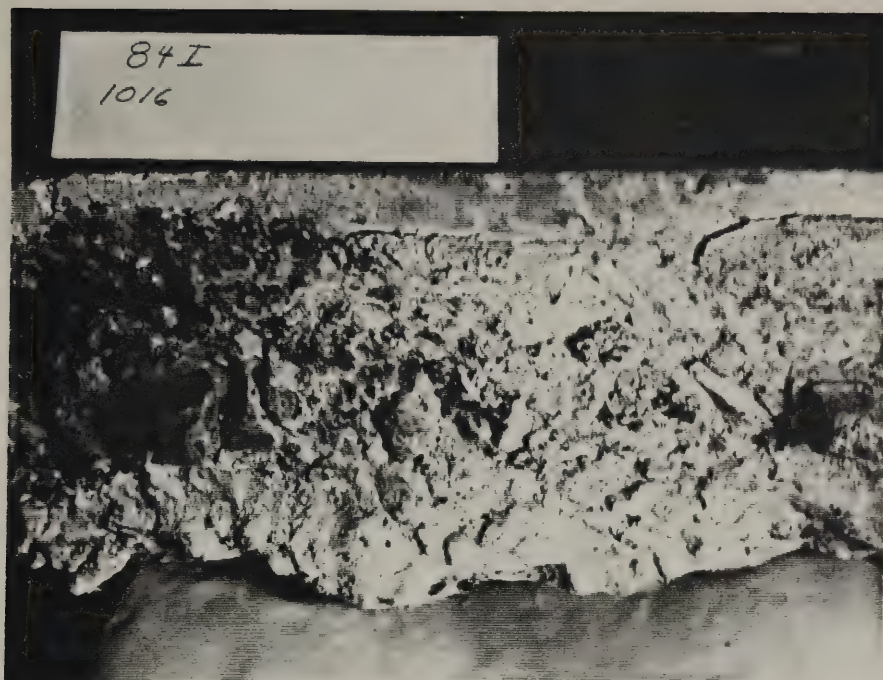
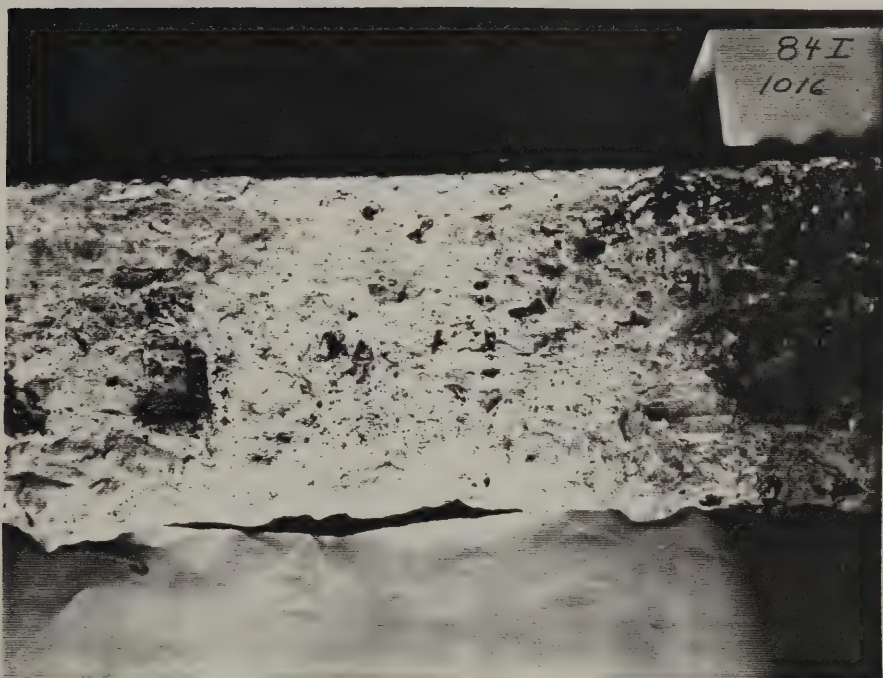
FISH 64-9 84I-83011016 E.B.

POOR JOINT

NOTE: Top portion of female section is missing.
